**Flood Control Project Maintenance
Levee Inspections**

Maintenance Issue Types Only, Levee Inspection Report By Mile - Spring 2016

San Joaquin County Flood Control and Water Conservation District

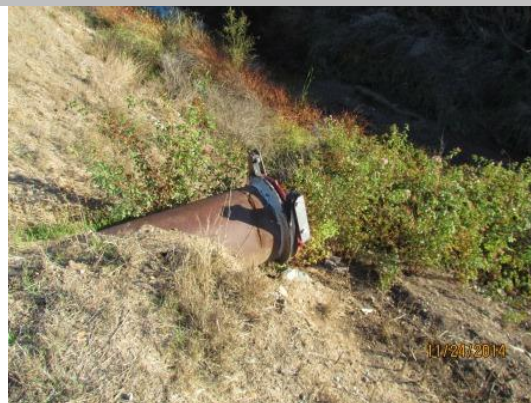
Photo 1 of 2 : SP_2016_NA0017_149_8_20160219_00004.jpg

LM Start	2.65	Rating **	A/W	Issue No.	8
LM End	2.65	Issue Type +	Ma	Location *	WS
Category	Earthen Levee			GPS Latitude/Longitude	
				Start	End
Item	Encroachments			37.888853 °	37.888853 °
				-121.258640 °	-121.258640 °
DWR ID	DWR_NA0017_02_s _ 2012_8				
Comment Code					
PI : Pipe					
Inspector Comment					
Pipe crossing the channel has corroded and can carry water to/from the channel. A flap gate was installed by the LMA, but the pipe appeared to be damaged.

A flap gate was installed at the end of the pipe, but the pipe appeared to have cracks. The picture was taken from the crown looking upstream during fall 2014 inspection.

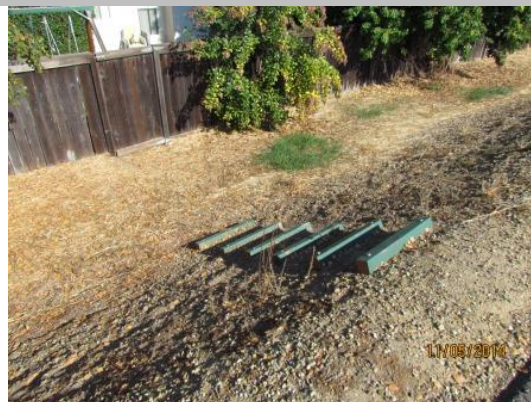
Photo 1 of 1 : SP_2016_NA0017_151_76_20160219_00036.jpg

A stairway was found on the landside of the levee looking upstream.

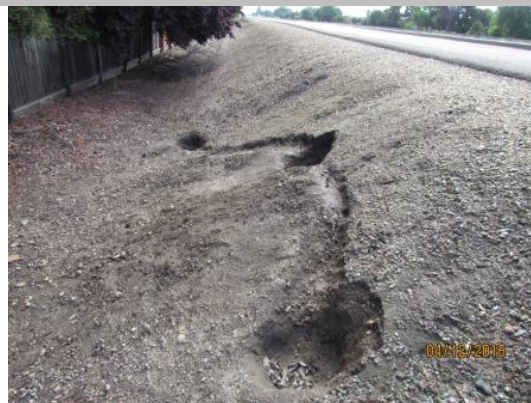
Photo 1 of 1 : SP_2016_NA0017_151_85_20160418_00151.jpg

LM Start	1.83	Rating **	M	Issue No.	85
LM End	1.83	Issue Type +	Ma	Location *	LS
Category	Earthen Levee			GPS Latitude/Longitude	
				Start	End
Item	Erosion / Bank Caving			38.043261 °	38.043261 °
				-121.340136 °	-121.340136 °
DWR ID	DWR_NA0017_07_s_2016_85				
Comment Code					
E2 : Schedule repair of erosion site prior to the next inspection.					
Inspector Comment					
Erosion caused by runoff

View of an erosion on the landside of the levee looking upstream.

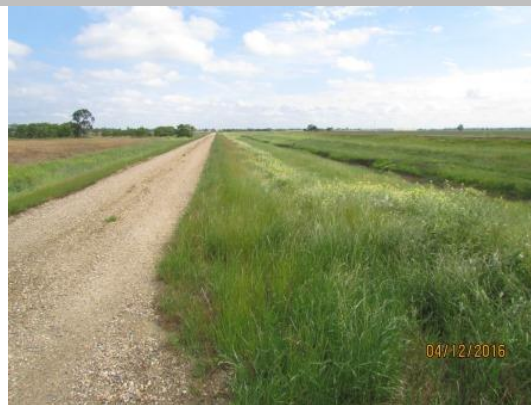
Photo 1 of 1 : SP_2016_NA0017_151_91_20160418_00155.jpg

View of vegetation on the waterside of the levee looking upstream.

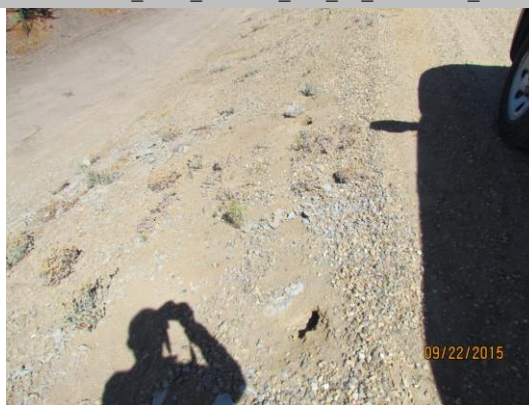
Photo 1 of 1 : SP_2016_NA0017_151_40_20160219_00016.jpg

Rodent holes were found on the landside slope of the levee looking upstream.

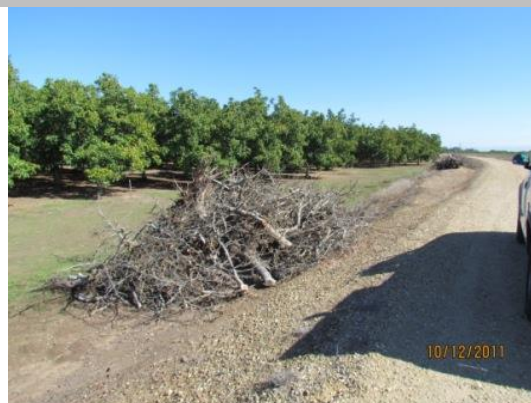
Photo 1 of 1 : SP_2016_NA0017_151_29_20160219_00007.jpg

LM Start	8.44	Rating **	M	Issue No.	29
LM End	8.44	Issue Type +	Ma	Location *	LS
Category	Earthen Levee			GPS Latitude/Longitude	
				Start	End
Item	Encroachments			38.068319 °	38.068319 °
				-121.231559 °	-121.231559 °
DWR ID	DWR_NA0017_07_s_2012_29				
Comment Code					
PR : Prunings					
Inspector Comment					
Burn pile has been burned but new material has been placed.

View of prunings found on the landside of the levee looking upstream.

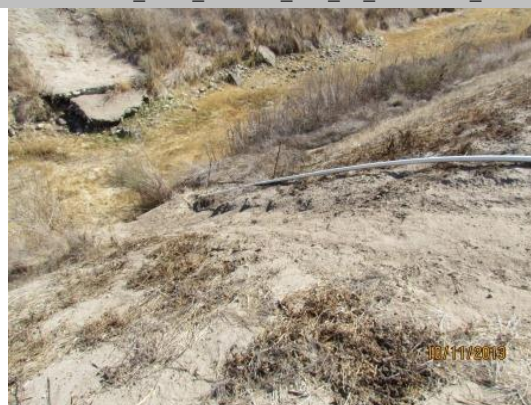
Photo 1 of 1 : SP_2016_NA0017_151_61_20160219_00031.jpg

Steps were found on the waterside slope of the levee looking downstream.

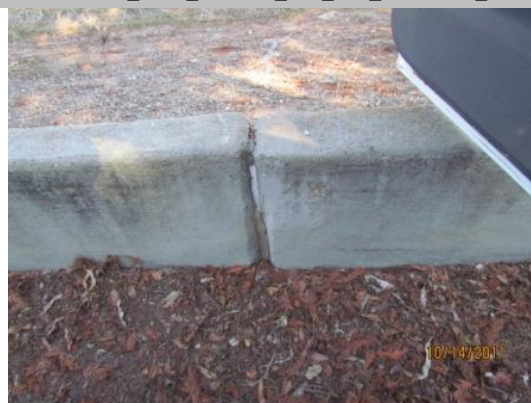
Photo 1 of 1 : SP_2016_NA0017_152_940_20160219_00046.jpg

Monolith joint material is deteriorating at the joint of the flood wall. The picture was taken from the crown looking upstream.

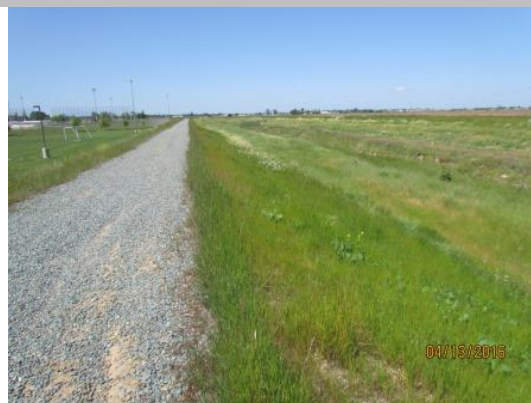
Photo 1 of 1 : SP_2016_NA0017_152_140_20160418_00209.jpg

View of the vegetation on the waterside of the levee.

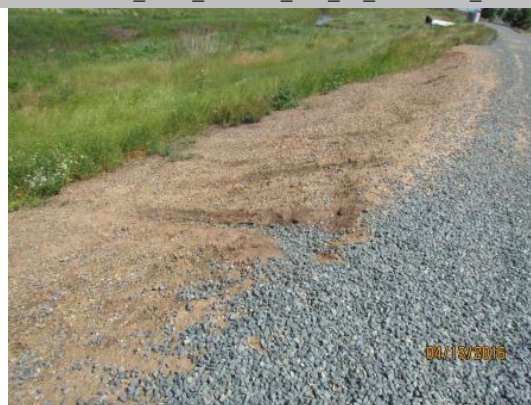
Photo 1 of 2 : SP_2016_NA0017_152_27_20160418_00210.jpg

LM Start	4.56	Rating **	M	Issue No.	27
LM End	4.56	Issue Type +	Ma	Location *	WS
Category	Earthen Levee			GPS Latitude/Longitude	
				Start	End
Item	Erosion / Bank Caving			38.042797 °	38.042797 °
				-121.300782 °	-121.300782 °
DWR ID	DWR_NA0017_08_s _ 2014_27				
Comment Code					
E2 : Schedule repair of erosion site prior to the next inspection.					
Inspector Comment					
Ruts on the waterside slope of the levee.

Updated picture of the erosion on the waterside shoulder of the levee during spring 2016 inspection.

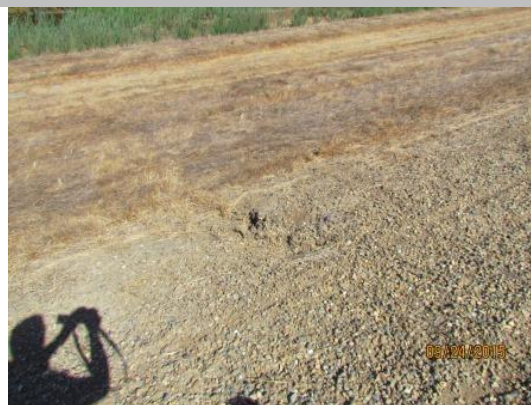
Photo 1 of 1 : SP_2016_NA0017_152_28_20160219_00008.jpg

Slope instability was found on the waterside of the levee looking upstream.

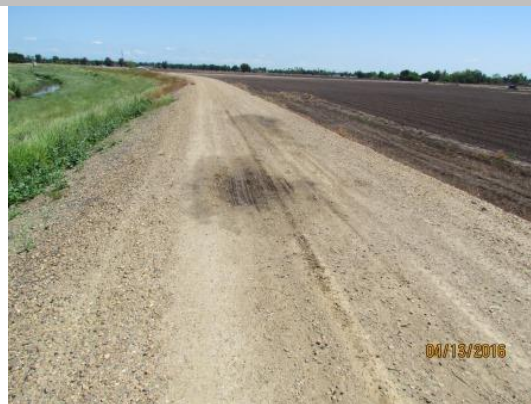
Photo 1 of 1 : SP_2016_NA0017_152_145_20160418_00215.jpg

View of crown depression on the levee.

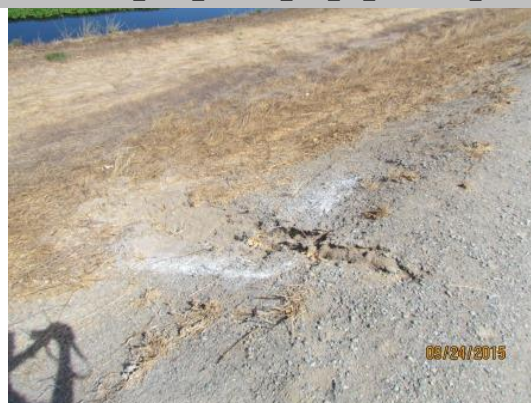
Photo 1 of 1 : SP_2016_NA0017_152_76_20160219_00027.jpg

A slope instability was found on the waterside of the levee looking upstream.

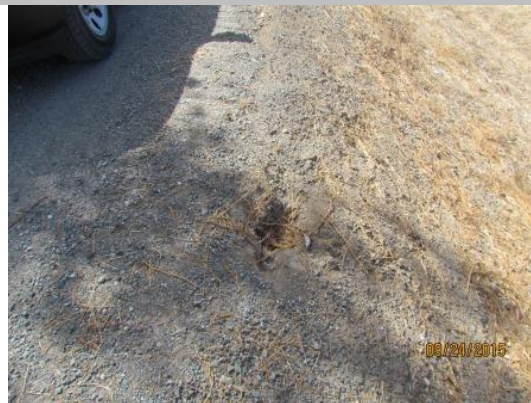
Photo 1 of 1 : SP_2016_NA0017_152_78_20160219_00028.jpg

An animal borrow was found on the waterside of the levee looking downstream.

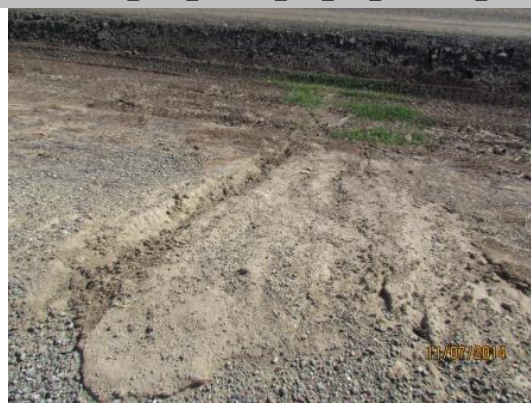
Photo 1 of 1 : SP_2016_NA0017_152_128_20160219_00045.jpg

Erosion was found on the landside of the levee looking upstream.

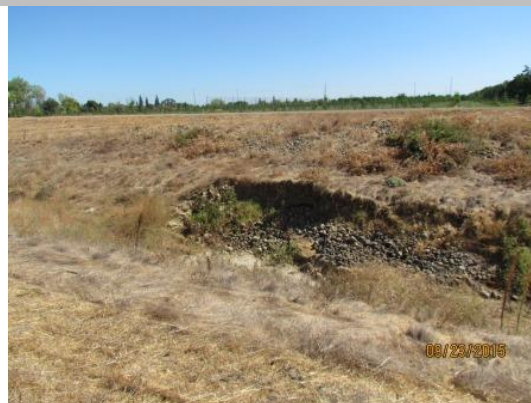
Photo 1 of 1 : SP_2016_NA0017_152_57_20160219_00017.jpg

Erosion was found on the waterside toe of the levee. The picture was taken from the right bank of the levee.

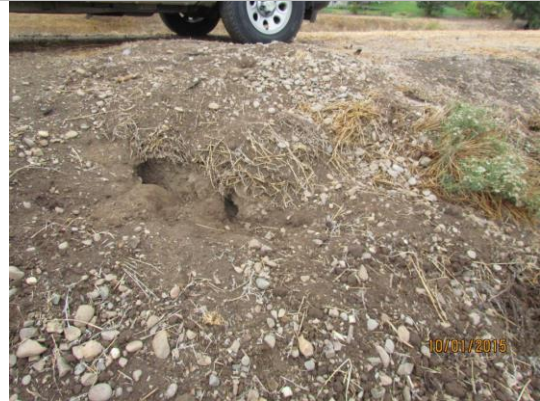
Photo 1 of 1 : SP_2016_NA0017_152_96_20160219_00039.jpg

Rodent holes were found on the landside slope of the levee looking upstream.

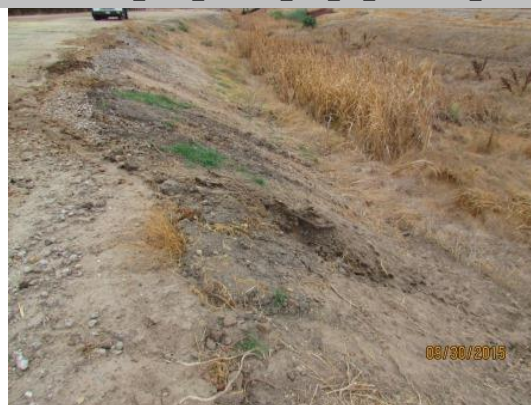
Photo 2 of 2 : SP_2016_NA0017_156_24_20160219_00011.jpg

View of the erosion on the waterside of the levee during fall 2015 inspection.

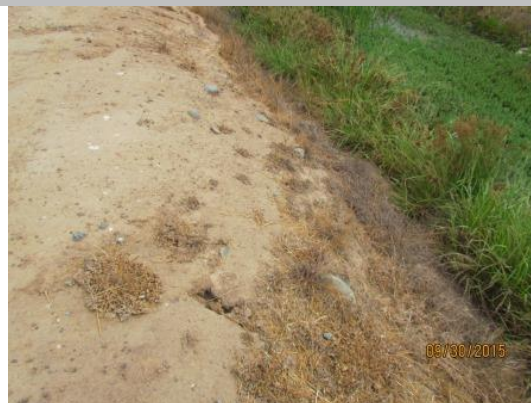
Photo 1 of 1 : SP_2016_NA0017_158_14_20160219_00009.jpg

Rodent holes were found on the waterside slope of the levee looking upstream.

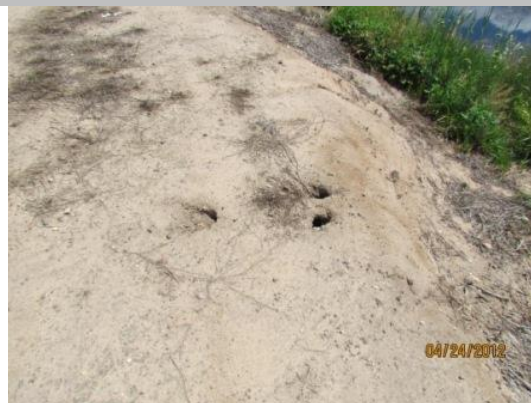
Photo 1 of 1 : SP_2016_NA0017_158_5_20160219_00006.jpg

View of animal holes that were found on the waterside of the levee looking upstream.

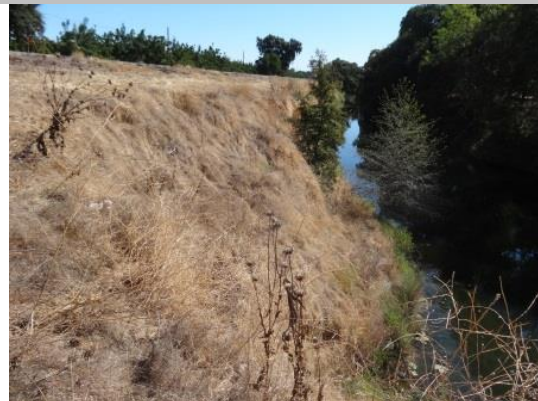
Photo 2 of 3 : SP_2016_NA0017_159_7_20160219_00011.jpg

Close view of the erosion site. Small trees grow at the lower slope of the bank.

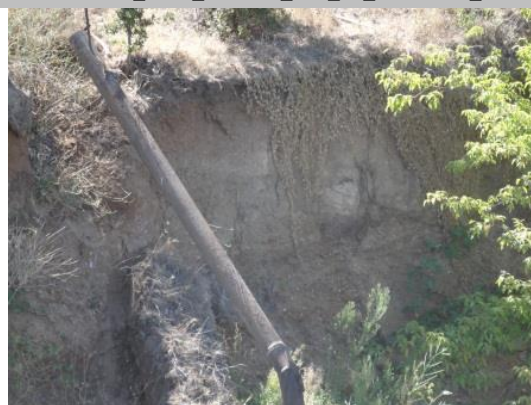
Photo 1 of 2 : SP_2016_NA0017_159_36_20160219_00057.jpg

Close view of the erosion.

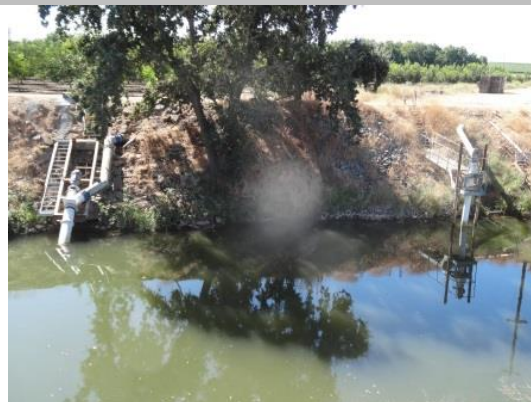
Photo 3 of 3 : SP_2016_NA0017_159_35_20160219_00056.jpg

Front view of the erosion and broken concrete protection on the levee slope.

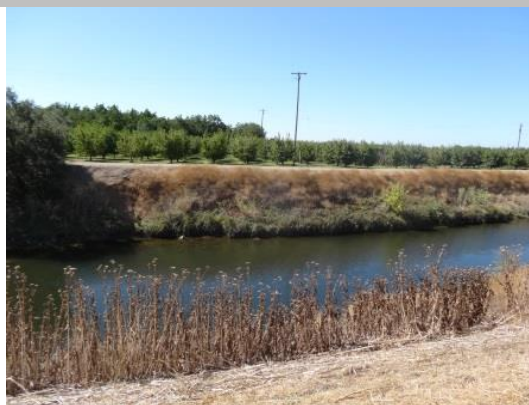
Photo 1 of 3 : SP_2016_NA0017_159_33_20160219_00050.jpg

Front view of the erosion.

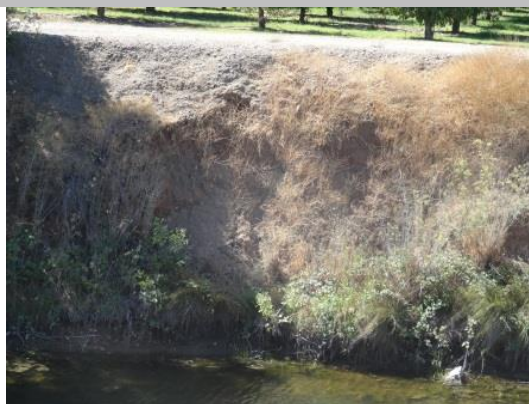
Photo 3 of 3 : SP_2016_NA0017_159_33_20160219_00052.jpg

Close view of the erosion.

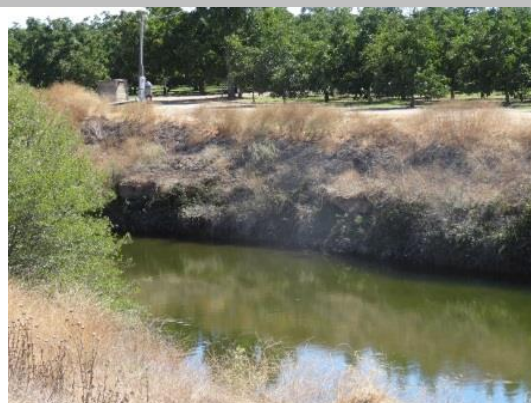
Photo 3 of 3 : SP_2016_NA0017_159_28_20160219_00043.jpg

Close view of the erosion.

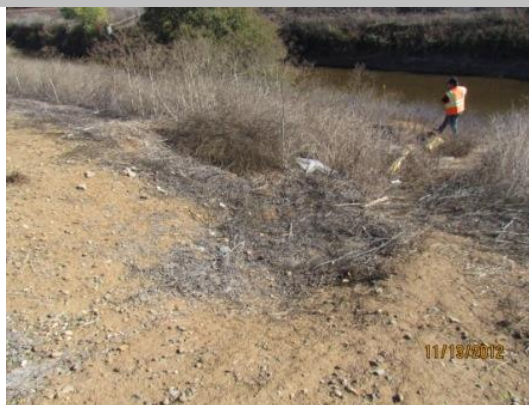
Photo 1 of 2 : SP_2016_NA0017_159_18_20160219_00028.jpg

Updated picture of the slope instability at the waterside slope of the levee looking upstream.

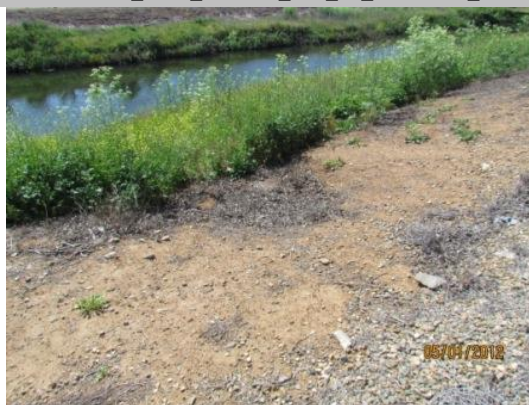
Photo 2 of 2 : SP_2016_NA0017_159_18_20160219_00029.jpg

Slope instability was found on the waterside toe of the levee looking downstream.

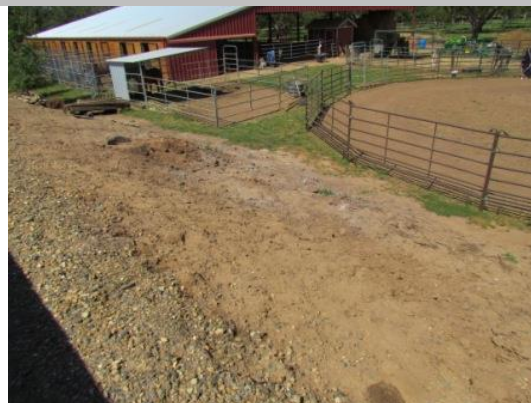
Photo 1 of 1 : SP_2016_NA0017_159_27_20160219_00040.jpg

Slope instability was found on the landside of the levee. The picture was taken from the crown looking downstream.

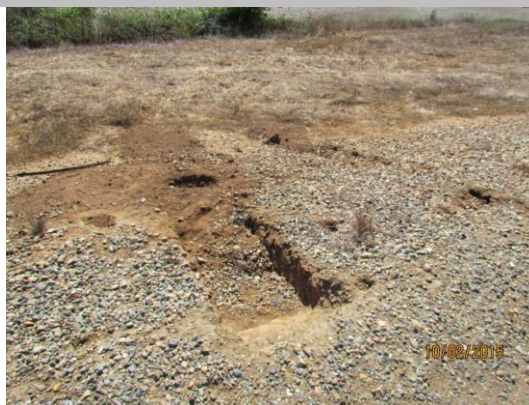
Photo 1 of 1 : SP_2016_NA0017_159_127_20160219_00109.jpg

Slope instability caused by vehicle on the waterside of the levee looking downstream.

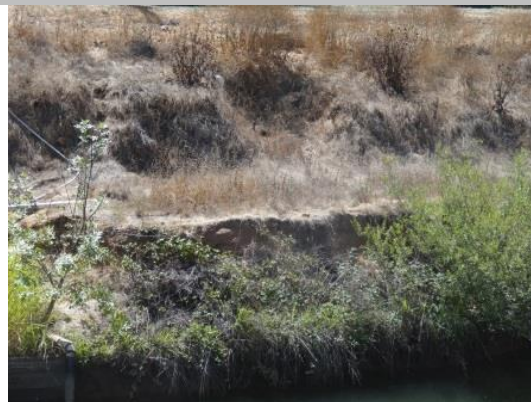
Photo 3 of 3 : SP_2016_NA0017_159_17_20160219_00027.jpg

Closer view of the erosion.

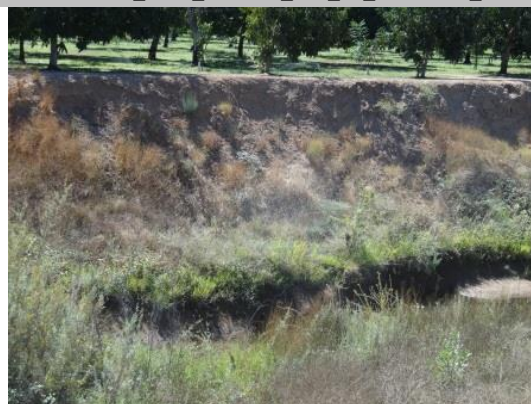
Photo 2 of 2 : SP_2016_NA0017_159_11_20160219_00019.jpg

A close view of the erosion.

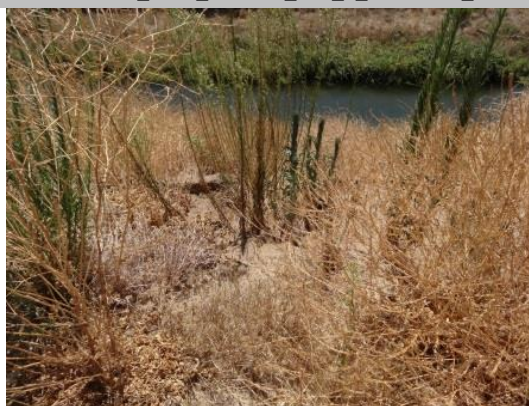
Photo 1 of 3 : SP_2016_NA0017_159_6_20160219_00007.jpg

Looking down at the erosion from the levee crest.

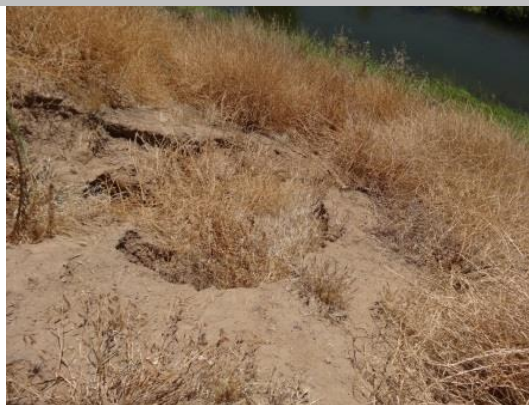
Photo 2 of 3 : SP_2016_NA0017_159_6_20160219_00008.jpg

Close view of the erosion.

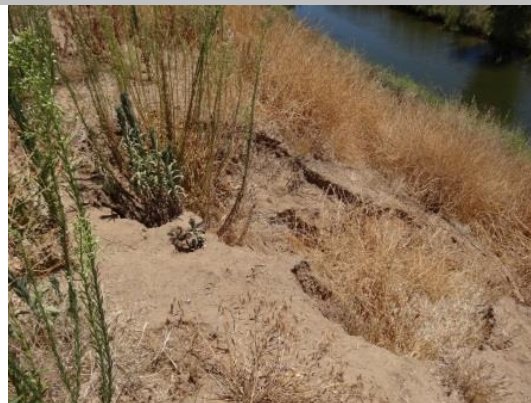
Photo 3 of 3 : SP_2016_NA0017_159_6_20160219_00009.jpg

Close view of the erosion.

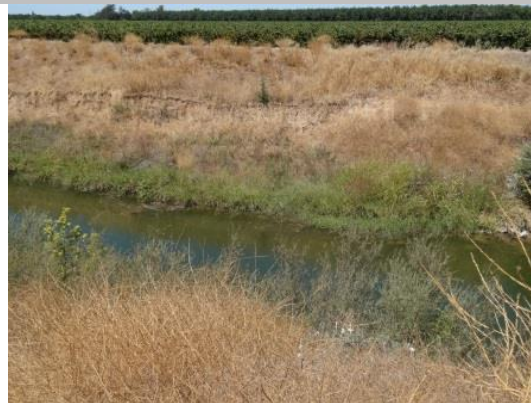
Photo 2 of 3 : SP_2016_NA0017_159_4_20160219_00004.jpg

Close view of the erosion.

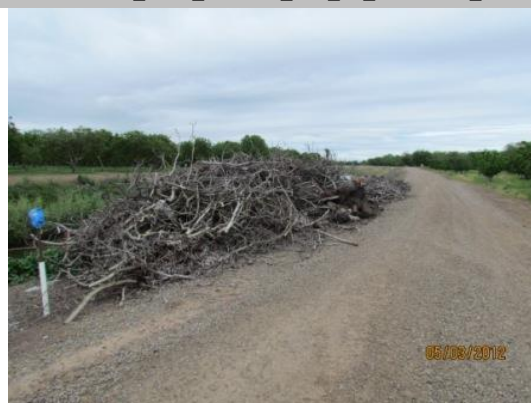
Photo 1 of 2 : SP_2016_NA0017_159_78_20160219_00084.jpg

Prunings were found on the waterside of the levee looking downstream.

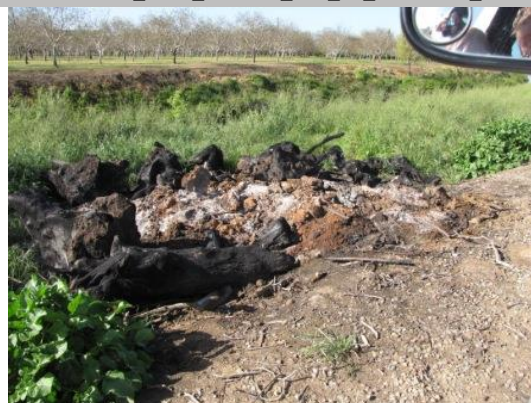
Photo 2 of 2 : SP_2016_NA0017_159_78_20160219_00085.jpg

View of the prunings pile on the waterward slope looking downstream.

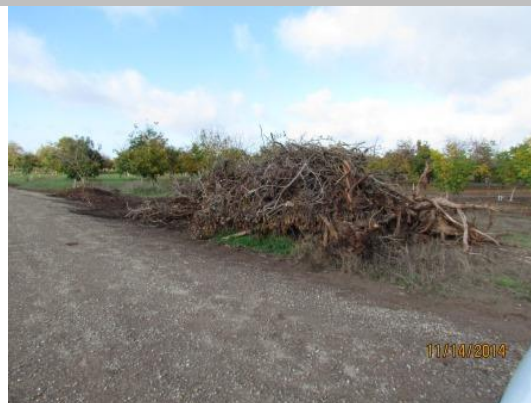
Photo 1 of 1 : SP_2016_NA0017_159_106_20160219_00098.jpg

Prunings were found on the landside of the levee looking downstream.

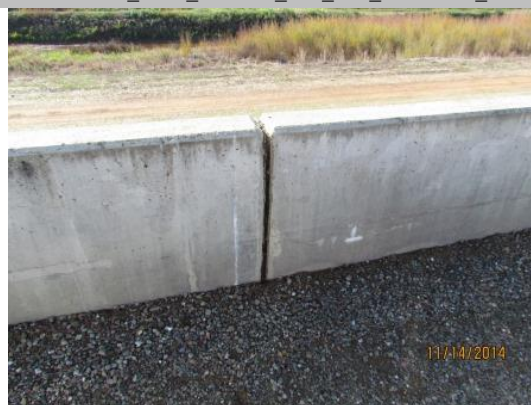
Photo 1 of 1 : SP_2016_NA0017_159_180_20160219_00136.jpg

The monolith joint is deteriorating on the waterside shoulder of the levee.

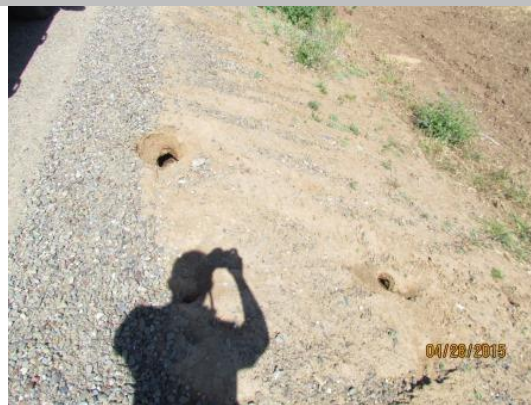
Photo 1 of 1 : SP_2016_NA0017_159_194_20160219_00141.jpg

Rodent holes were found on the landside of the levee looking downstream.

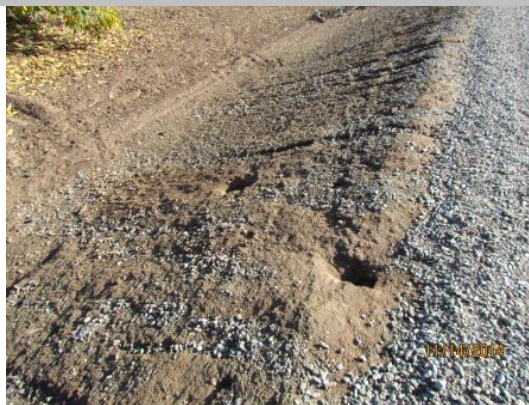
Photo 2 of 2 : SP_2016_NA0017_159_71_20160219_00082.jpg

View of the animal holes on the landside of the levee looking upstream during fall 2014 inspection.

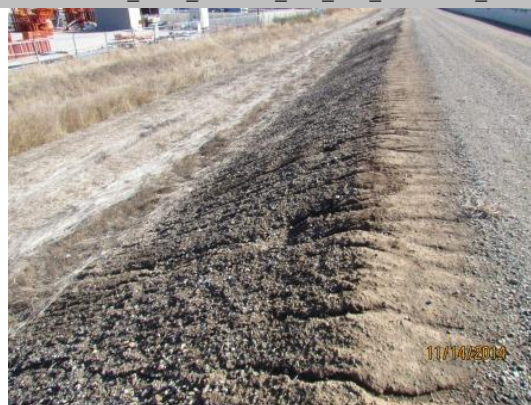
Photo 1 of 1 : SP_2016_NA0017_159_184_20160219_00137.jpg

Erosion caused by surface runoff was found on the landside of the levee looking upstream.

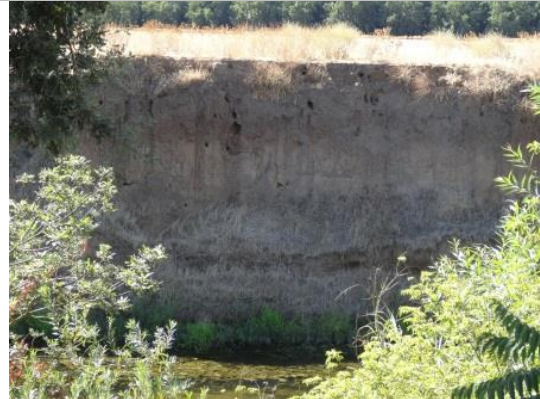
Photo 1 of 3 : SP_2016_NA0017_160_82_20160219_00076.jpg

Close view of the erosion.

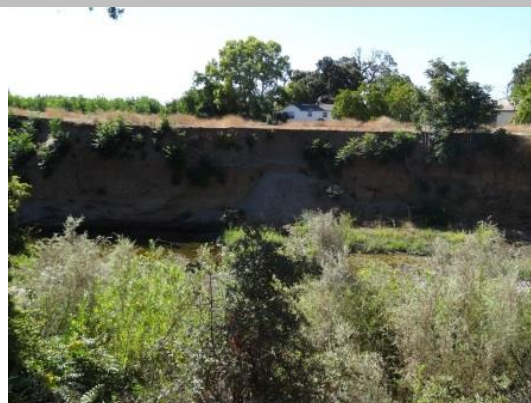
Photo 3 of 3 : SP_2016_NA0017_160_82_20160219_00078.jpg

Close view of the erosion. Signs of new erosion along the site.

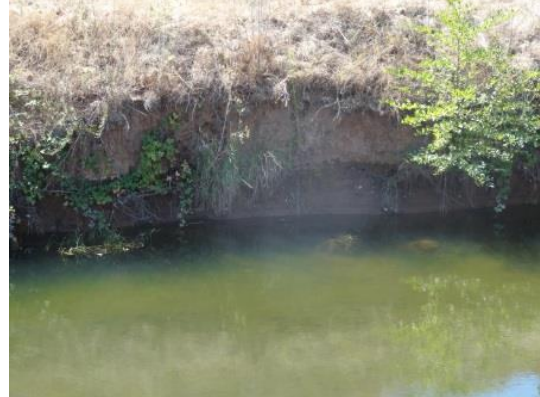
Photo 3 of 3 : SP_2016_NA0017_160_76_20160219_00073.jpg

Close view of the erosion.

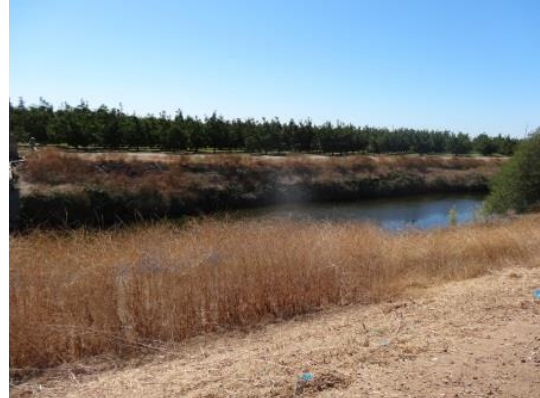
Photo 1 of 3 : SP_2016_NA0017_160_75_20160219_00068.jpg

Looking at the erosion from right river bank.

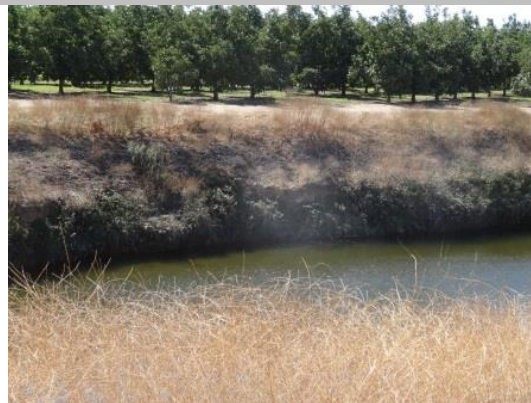
Photo 2 of 3 : SP_2016_NA0017_160_75_20160219_00069.jpg

Front view of the erosion.

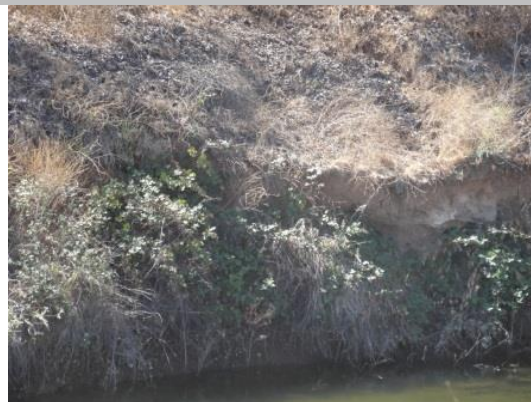
Photo 3 of 3 : SP_2016_NA0017_160_75_20160219_00070.jpg

Close view of the erosion. Note the dense vegetation.

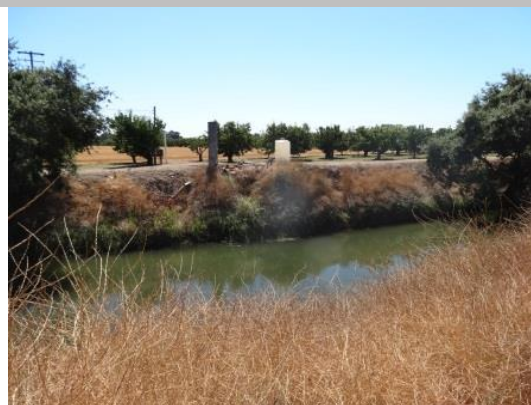
Photo 1 of 2 : SP_2016_NA0017_160_47_20160219_00036.jpg

View of the erosion site.

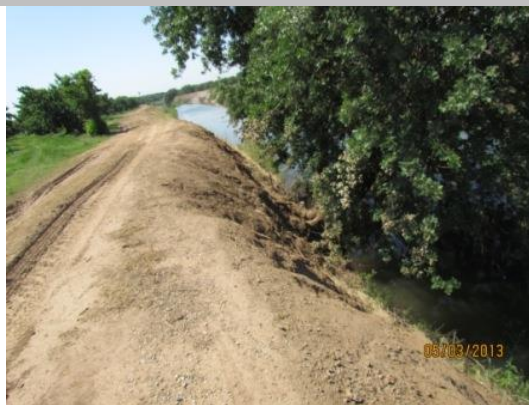
Photo 2 of 2 : SP_2016_NA0017_160_228_20160219_00138.jpg

Slope instability was found on the waterside shoulder of the levee looking downstream.

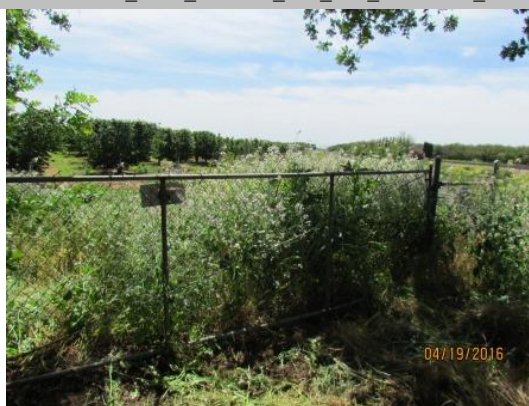
Photo 1 of 1 : SP_2016_NA0017_160_271_20160425_00367.jpg

View of vegetation on the crown that was obstructing the visibility and accessibility on the levee. The picture was taken from the crown looking downstream.

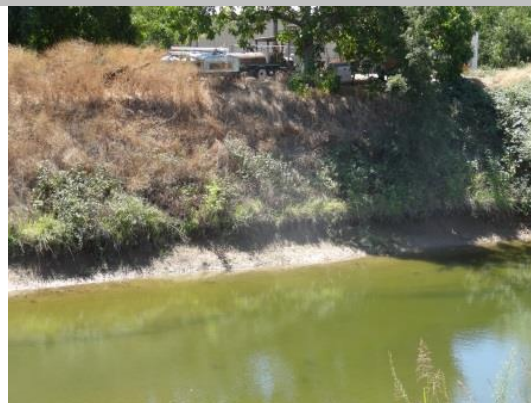
Photo 2 of 2 : SP_2016_NA0017_160_39_20160219_00027.jpg

Close view of the erosion.

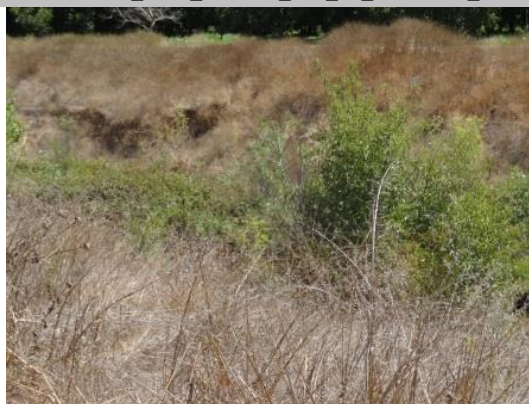
Photo 2 of 3 : SP_2016_NA0017_160_38_20160219_00024.jpg

Closer view of the erosion.

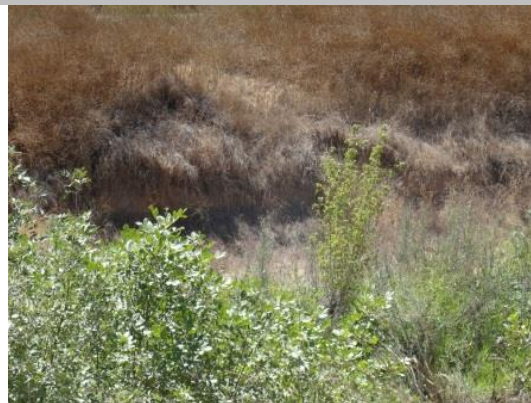
Photo 3 of 3 : SP_2016_NA0017_160_38_20160219_00025.jpg

Close view of the erosion.

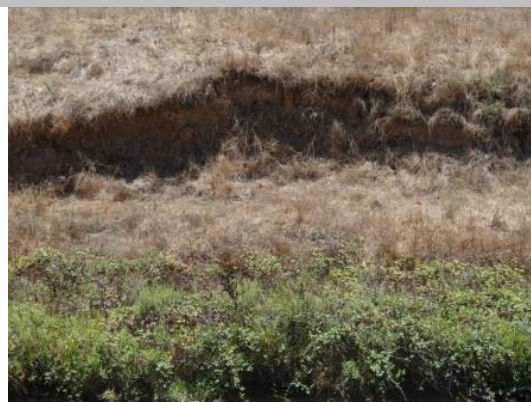
Photo 2 of 2 : SP_2016_NA0017_160_36_20160219_00020.jpg

Close view of the erosion.

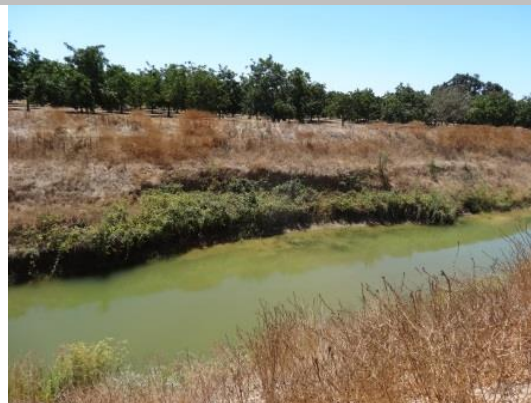
Photo 1 of 2 : SP_2016_NA0017_160_10_20160219_00003.jpg

Front view of the erosion.

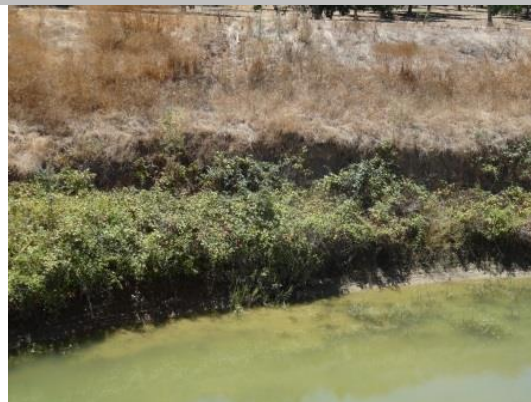
Photo 2 of 2 : SP_2016_NA0017_160_10_20160219_00004.jpg

Closer view of the erosion.

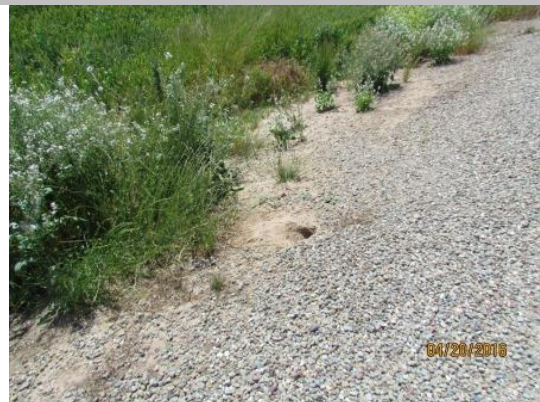
Photo 1 of 1 : SP_2016_NA0017_160_286_20160427_00375.jpg

View of a rodent hole on the landside of the levee.

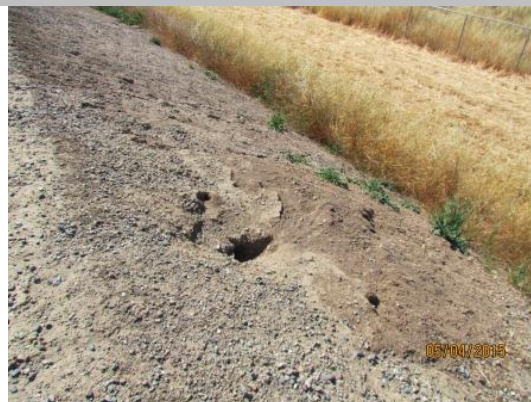
Photo 1 of 1 : SP_2016_NA0017_160_273_20160219_00153.jpg

Rodent holes were found on the landside of the levee looking upstream.

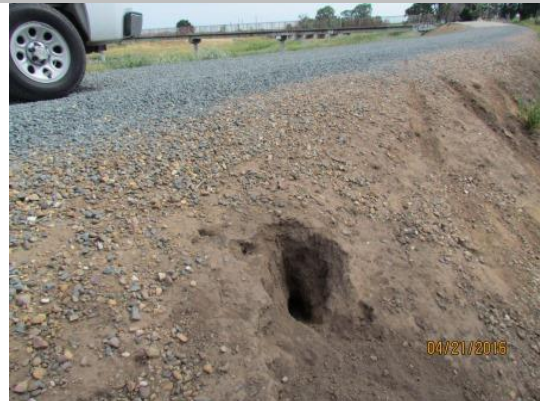
Photo 1 of 1 : SP_2016_NA0017_160_294_20160427_00381.jpg

An animal burrow was found on the landside shoulder of the levee looking upstream.

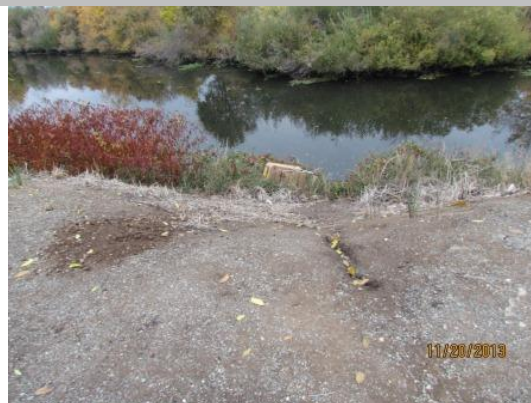
Photo 1 of 1 : SP_2016_NA0017_160_74_20160219_00067.jpg

Erosion due to runoff was found on the waterside of the levee looking upstream.

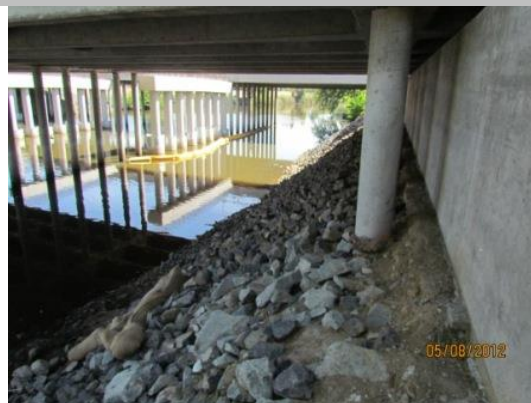
Photo 4 of 5 : SP_2016_NA0017_160_48_20160219_00041.jpg

View of the erosion site repaired by Caltrans under the I-5 freeway going southbound. This picture was taken from the toe of the levee looking upstream.

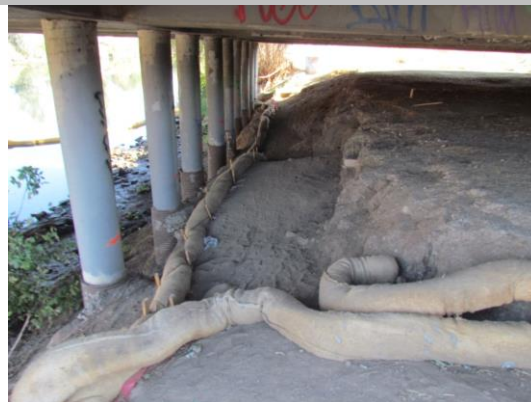
Photo 5 of 5 : SP_2016_NA0017_160_48_20160219_00042.jpg

View of the erosion under the I-5 bridge looking upstream.

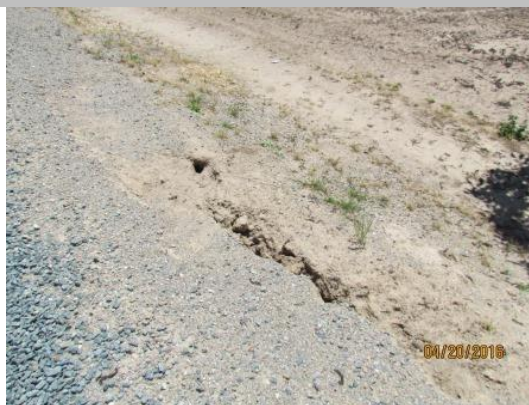
Photo 1 of 1 : SP_2016_NA0017_162_4_20160427_00006.jpg

Rodent holes were found on the landside of the levee.
